Cummins/Onan Detector 12

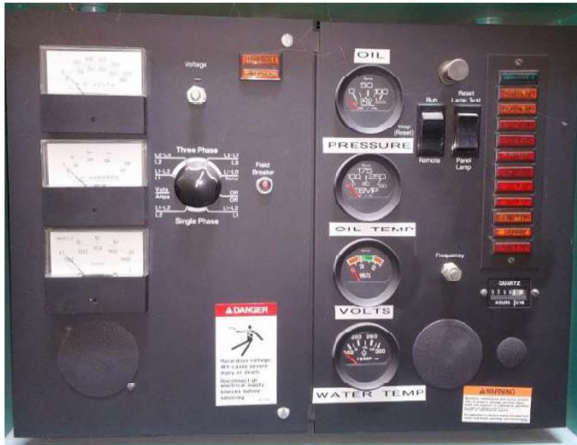
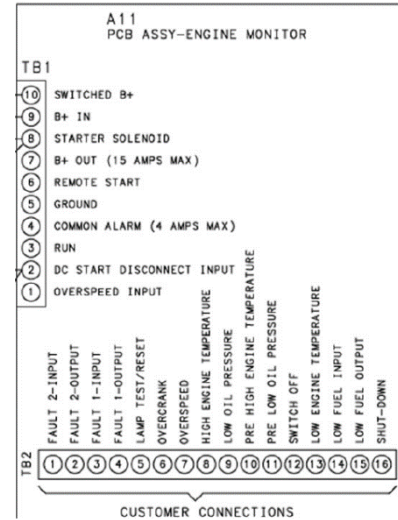
Generac Gateway Side Termination	Description	Wire Color	Customer Side Terminations
TB1 V+	DC+	Red	TB1-9*
TB1 V-	DC-	Black	TB1-5*
TB2 DICOM	Input Common	Orange	TB1-5
TB2 DI0	Engine Running	Purple	TB1-10
TB2 DI1	Not In Auto	Green	**Relay install required. See diagram.
TB2 DI2	Common Alarm	White	TB1-4
Harness Relay #1	COM	Blue	TB1-6
	N/O	White / Blue	TB1-9

*If MODEM and signal lights turn off and data is lost after gen crank, this can indicate a brief loss of power. To correct, ensure red and black wires are connected directly to the battery posts.

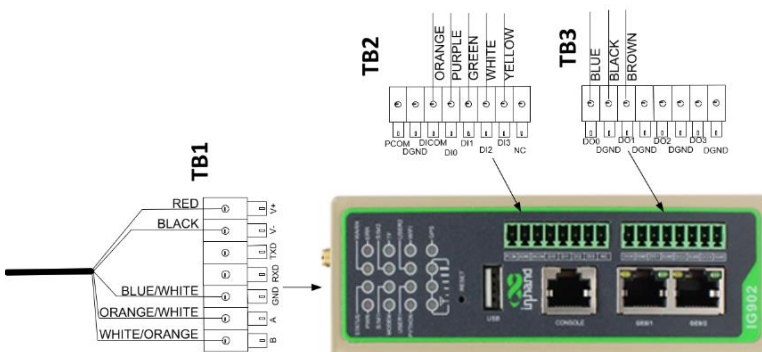
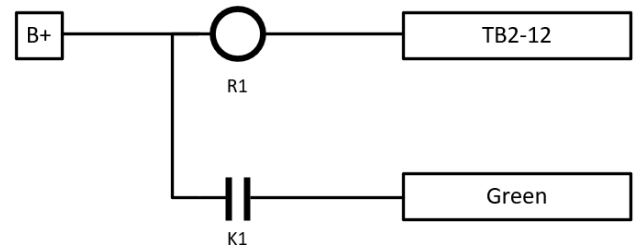
**Relays will need to be installed to change switched ground contacts into switched B+. Relay coil rating will need to match system battery voltage.
