Cummins PCC 2100

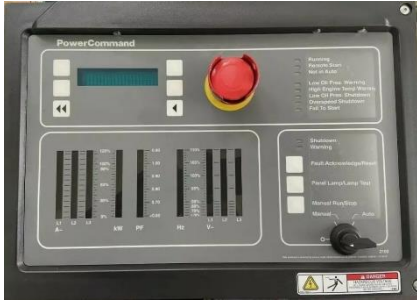
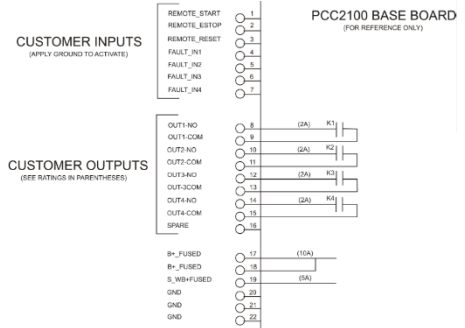
| Generac Gateway Side Termination | Description | Wire Color | Customer Side Terminations |
| TB1 V+ | DC+ | Red | TB1-17 or 18 Jump DC+ to TB1-9, 11, and 13 |
| TB1 V- | DC- | Black | TB1-20, 21, or 22 |
| TB2 DICOM | Input Common | Orange | TB1-20, 21, or 22 |
| TB2 DI0 | Engine Running | Purple | TB1-19 |
| TB2 DI1 | Not In Auto | Green | TB1-12 |
| TB2 DI2 | Common Alarm | White | TB1-8 Jump TB1-8 to 10 |
| Harness Relay #1 | COM | Blue | TB1-1 |
| | N/O | White / Blue | TB1-20, 21, or 22 |

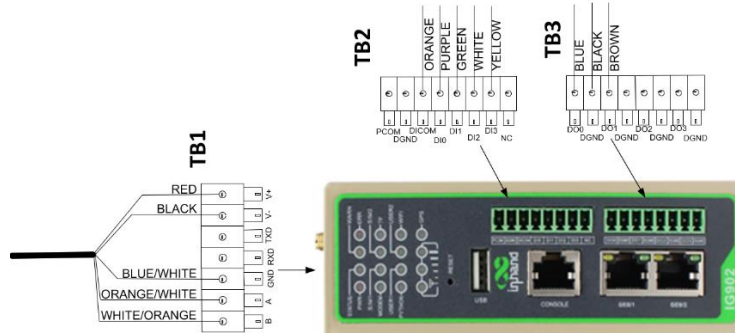
*If MODEM and signal lights turn off and data is lost after gen crank, this can indicate a brief loss of power. To correct, ensure red and black wires are connected directly to the battery posts.
