Kohler 16 Light Controller

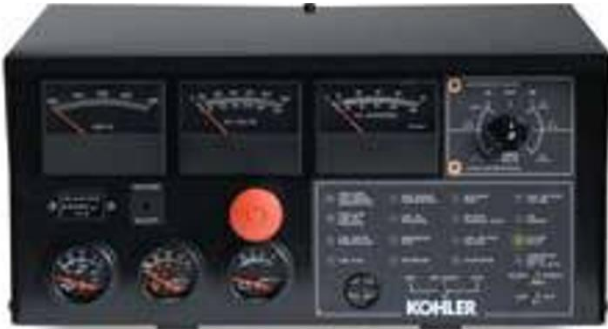
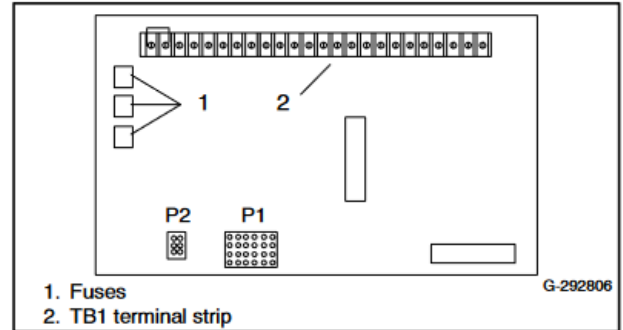
Generac Gateway Side Termination	Description	Wire Color	Customer Side Terminations
TB1 V+	DC+	Red	TB1-42A*
TB1 V-	DC-	Black	TB1-2*
TB2 DICOM	Input Common	Orange	TB1-2
TB2 DI0	Engine Running	Purple	Hour Meter+ (Wire 70)
TB2 DI1	Not In Auto	Green	**Relay install required. See diagram.
TB2 DI2	Common Alarm	White	**Relay install required. See diagram.
Harness Relay #1	COM	Blue	TB1-3
	N/O	White / Blue	TB1-4

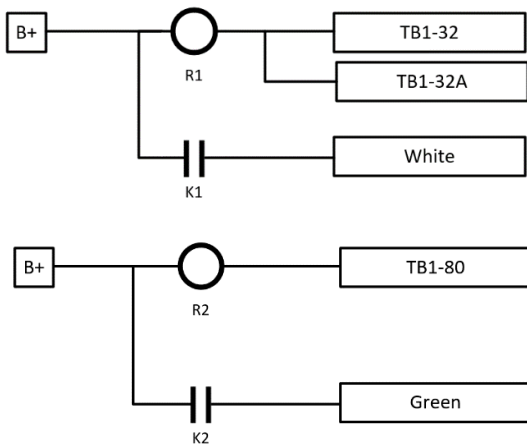
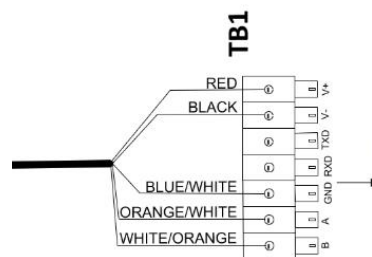
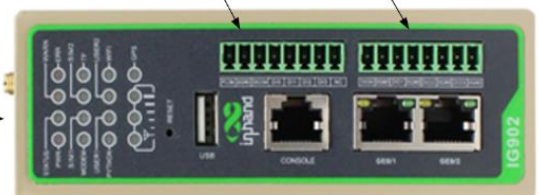
**Relays will need to be installed to change switched ground contacts into switched B+. Relay coil rating will need to match system battery voltage.
